How to debug a positioning issue with a specific Android phone

How to measure the RSSI@1m on the problematic device

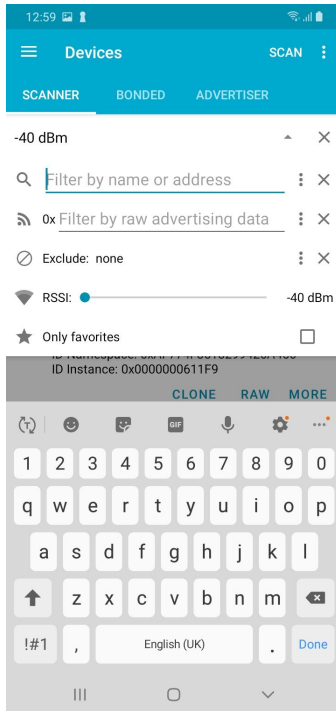
Step 2

Open the app, then select the scanner tab from the top.

Click filter and set the RSSI to -40dBm which means it will only display a beacon that's very close to the phone.

Place our beacon somewhere with the top (Steerpath label) facing you holding the phone.

Hold the phone touching the beacon and click Scan. The beacon should appear in the list in the app.

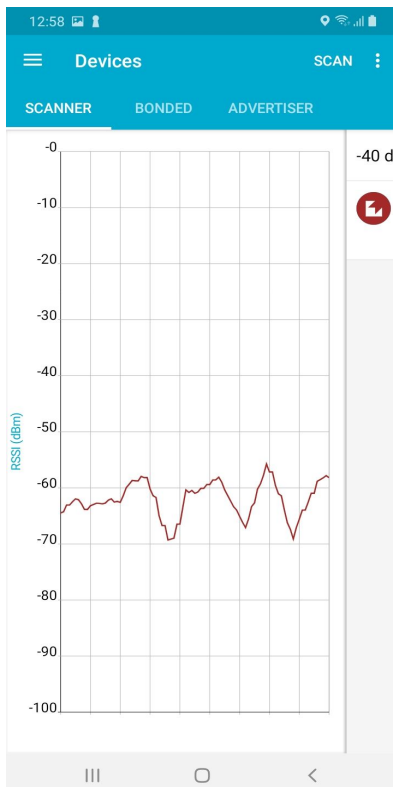
Move back and hold the phone 1 metre distance from the beacon. Then slide the list across to show the graph view as seen below.

The graph will start to plot the RSSI measurements as they arrive. You can click the Scan button again to get a more results

The RSSI measurements should be around -63dBm but it will oscillate above and below as shown in the example to the left. This is completely normal and to be expected.

A mobile phone with poor indoor positioning will typically have a much higher or lower average RSSI. Sometimes the difference can be as much as +/- 20dBm
